TECHNICAL REPORT REMR-CS-6

**IN SITU REPAIR OF DETERIORATED
CONCRETE IN HYDRAULIC STRUCTURES:
FEASIBILITY STUDIES**

R. P. Webster, L. E. Kukacka

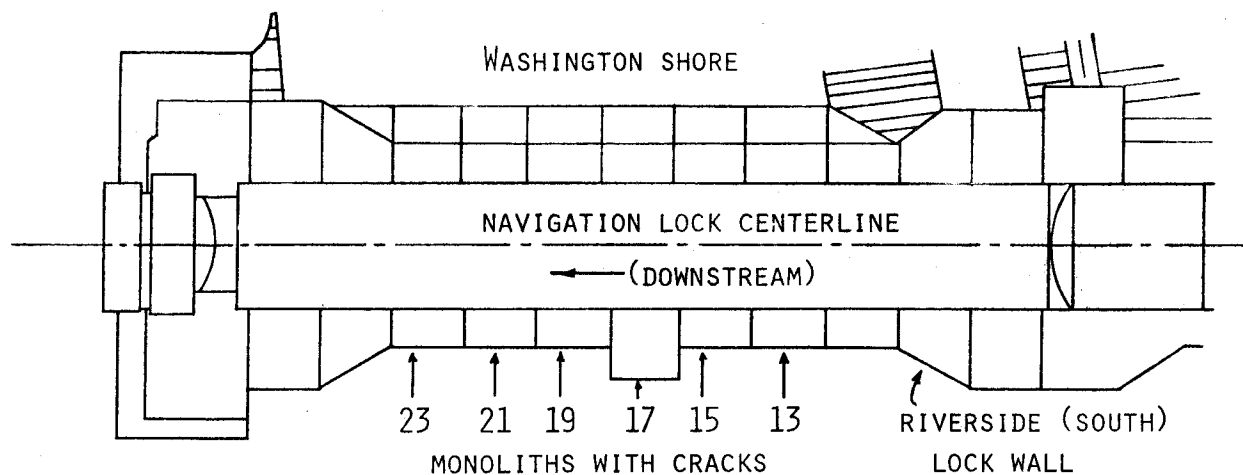
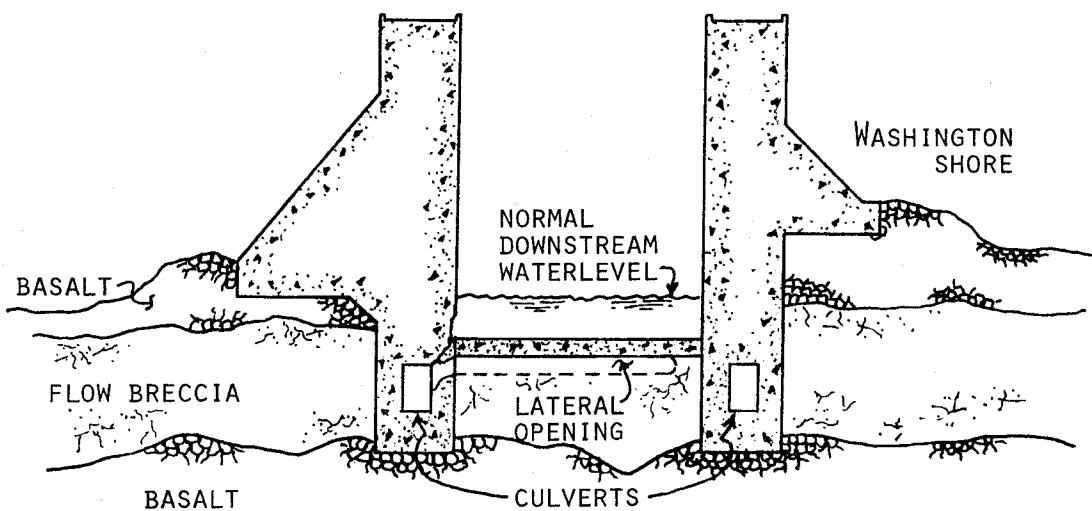
Figure 14. John Day Navigation Lock.

During an inspection in 1975, significant structural cracking and related spalling were discovered in two of the lock monoliths, monoliths 17 and 19. By 1979, cracking and spalling had been detected in four additional monoliths, monoliths 13, 15, 21, and 23. The structural distress in the monoliths consisted of cracks that originated at and propagated from the upper inside corner of the filling and emptying culvert and terminated at the surface of the wall in the lock chamber. Because of the continued progression of the cracking and spalling, a series of remedial repair procedures were devised and implemented to halt and correct the ongoing deterioration (Adhesive Engineering Bulletin, 1981b, Barlow, 1986, and Neuberger, 1982).

The objectives of the selected repair procedures were to restore the existing cracked structure to near its original uncracked condition, to eliminate the cause of the cracking, and to effect the repairs without
